# Manhole Inspection Summary

Manhole # S02YY1007MH

**Inspection** ☐ Is Incomplete Rating: **3) Fair**

**Location** Address: **3702 Fords Ln**

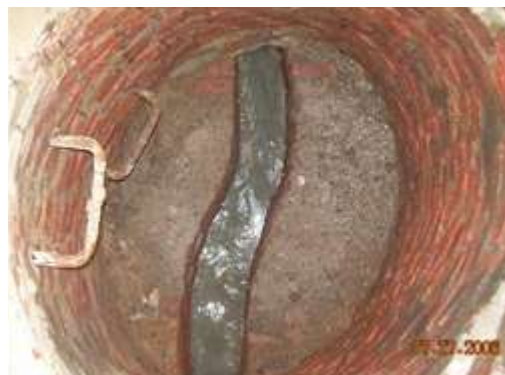
Top View

Condition: ☐ Sound ☐ Cracked ☐ Root Intrusion ☒ **Deteriorated** ☐ Leaks ☐ Debris

**Steps** Count: **2** Missing: **0** ☒ **Corroded**

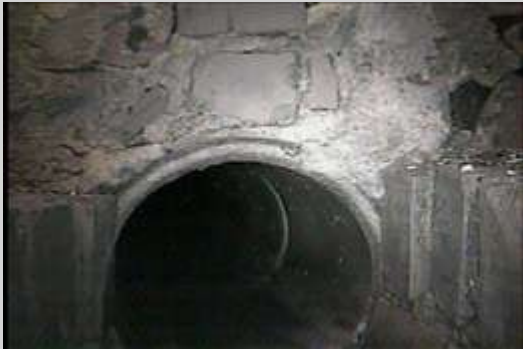
### 8 in. Circular Gravity Sewer Pipe Out @ 12 O'Clock

Pipe Material: **Clay** ☐ Pipe Lined

Invert Depth: **6.21** (ft.) Flow Characteristics: **Fast**

Deposits: ☒ None ☐ Mud ☐ Sludge ☐ Debris ☐ Grease

Infiltration: **None** Pipe Seal Cond: **Sound**

Drop: **None**

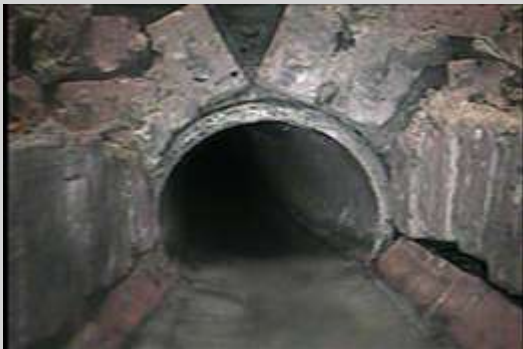
### 8 in. Circular Gravity Sewer Pipe In @ 6 O'Clock

Pipe Material: **Clay** ☐ Pipe Lined

Invert Depth: **6.12** (ft.) Flow Characteristics: **Fast**

Deposits: ☒ None ☐ Mud ☐ Sludge ☐ Debris ☐ Grease

Infiltration: **None** Pipe Seal Cond: **Sound**

Drop: **None**
